Derryadd Bog

**Draft Cutaway Bog Decommissioning
and Rehabilitation Plan**

2025

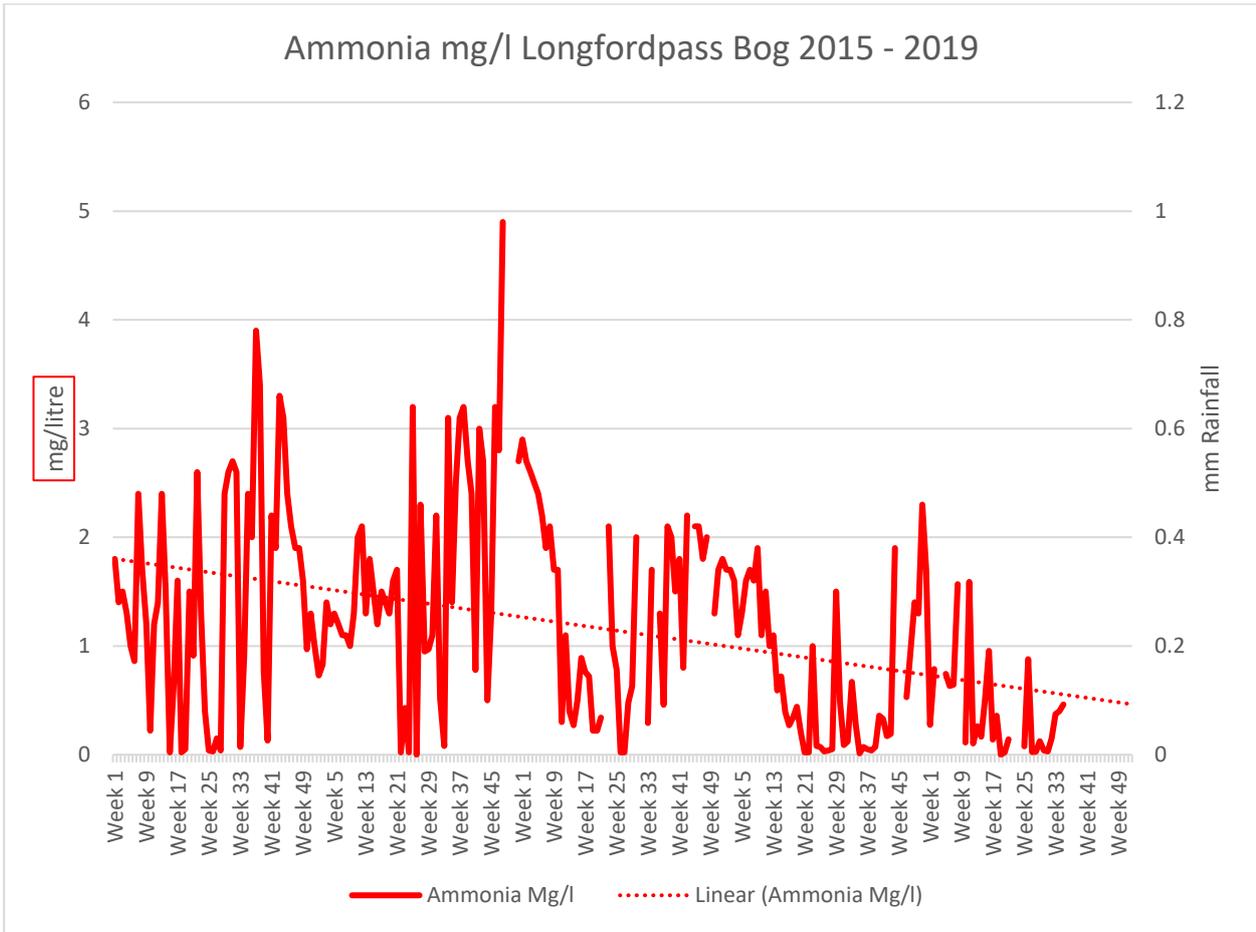
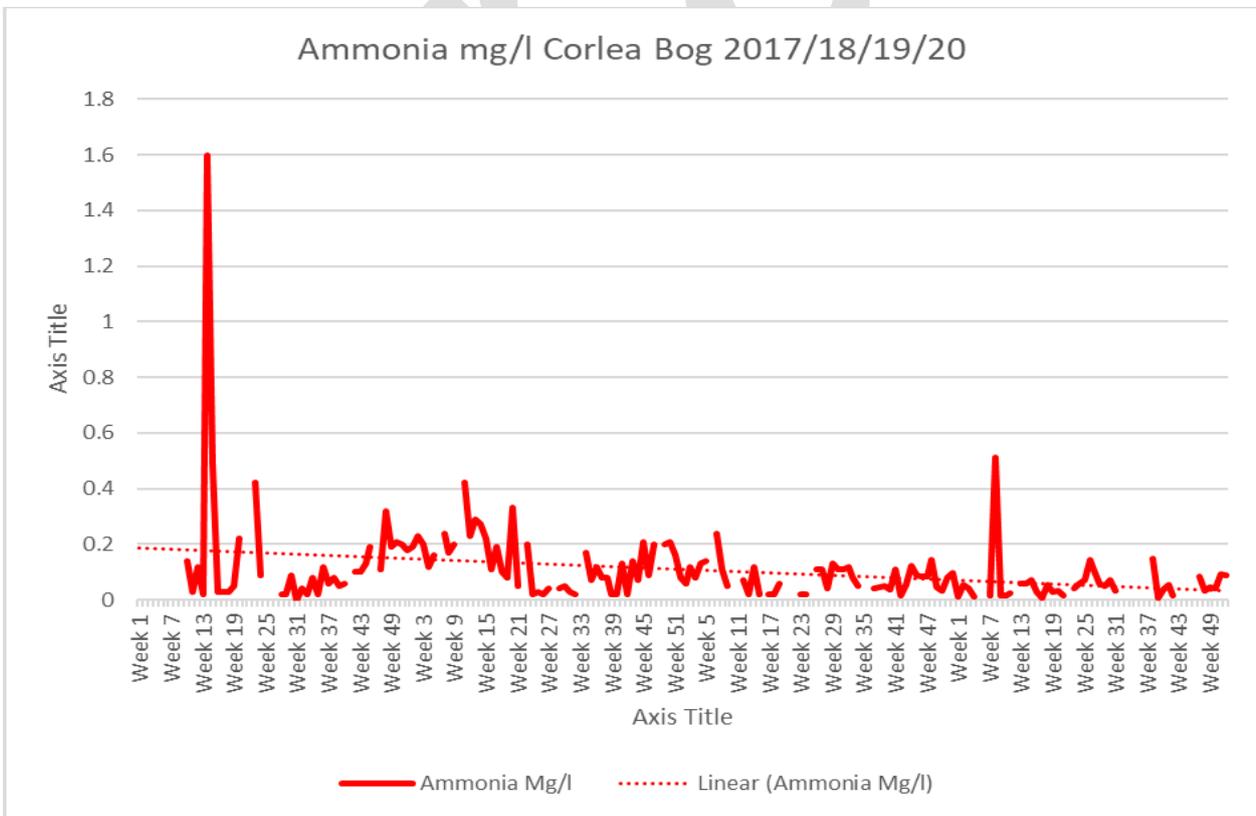
Figure 7.1. Ammonia levels over the period 2015-2019/2020 at Longfordpass and Corlea.

With regard to predicting and estimating likely trends that might materialize or could be considered as a target, monitoring of surface water ammonia emissions from Longfordpass bog in Littleton over 3 years, post cessation of peat extraction with ongoing rehabilitation, were considered. These are indicating a downward trend in Ammonia concentrations (Figure 7.1).

Similarly monitoring of surface water ammonia emissions from a Corlea bog in Moundillon over the past 3 years post cessation of peat extraction with ongoing rehabilitation, indicate downward trends.
